Buildings for Storing Cultural Heritage Objects

— Principles and Methods for Assessing Indoor Environments

The publication was released as a part of the NAKI DF13P01OVV016, scientific and research project of the Czech Ministry of Culture, made by the Technical Museum in Brno, the National Heritage Institute and the Moravian Gallery in Brno.

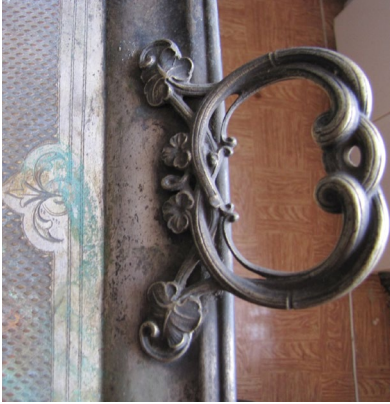
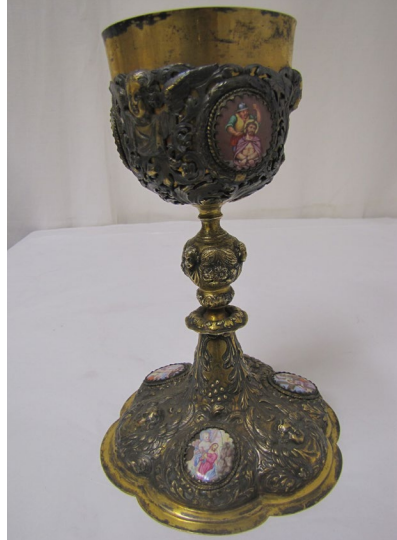
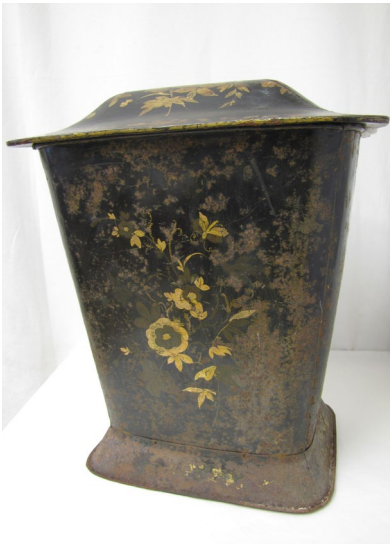
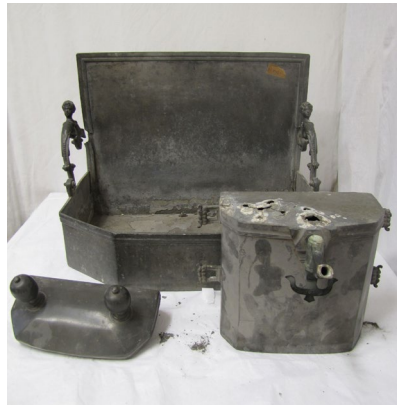
Relative humidity can cause corrosion of painted metal objects and subsequent loosening and disintegration of paint layers and, therefore, irreversible damage to decorated metal household articles.

- ↑ An example of the effects of higher relative humidity on a metal surface – corrosive products on an alpaca tray (patina)
- ↑ An example of an oxide layer on the surface of a chalice caused by higher relative humidity and damage caused to the enamel by fingers
- ↗ An example of corroded metal basket due to high relative humidity which has induced flaking of the painted decoration
- ↗ An example of the effects of acidic environment and humidity on a tin lavabo resulting in its local destruction

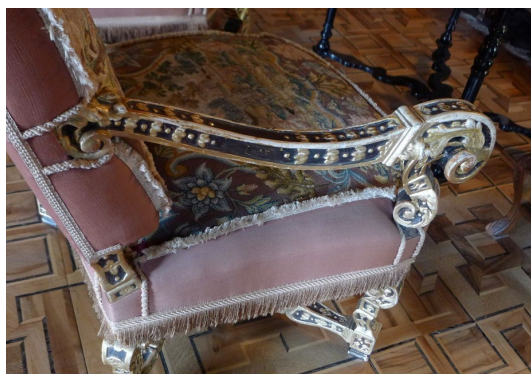
An example of the effects of light on the colours and embrittlement of textile fibres

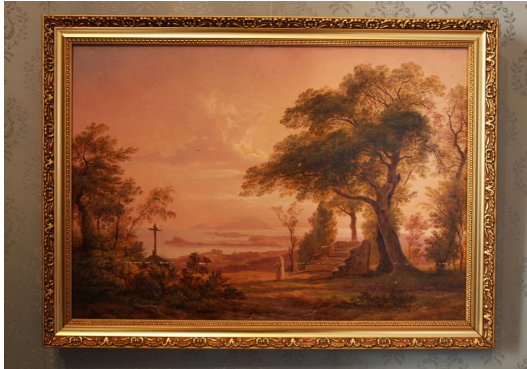
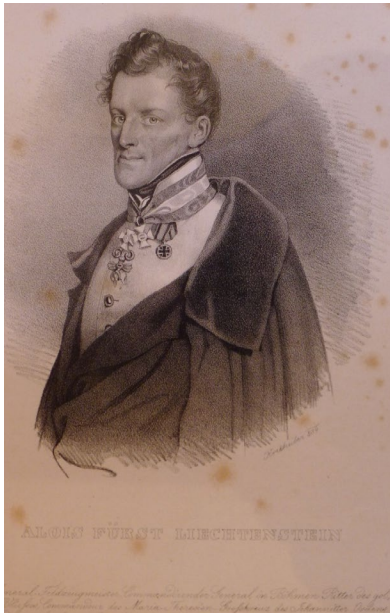
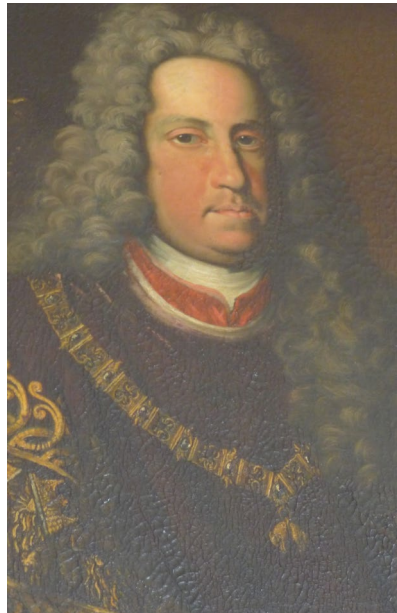
- ↑ An example of a painting damaged due to cracks in the wooden support base and flaking of the paint layer
- ↑ An example of damage to a framed graphic (lithograph) caused by mould formed due to humidity and light (gradual fading of colour in comparison with a print kept in a depository)
- ↗ An example of the effects of a heat source on the degradation of a painting (oil on canvas)

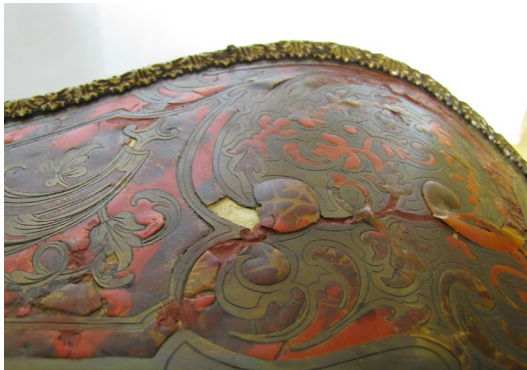
An example of inlaid furniture (Boulle Work) damaged by tensions in the materials due to abrupt changes of the environmental conditions

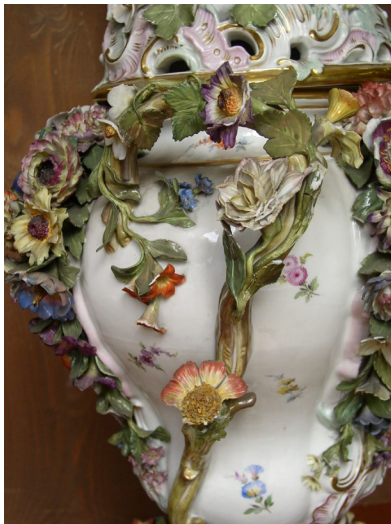
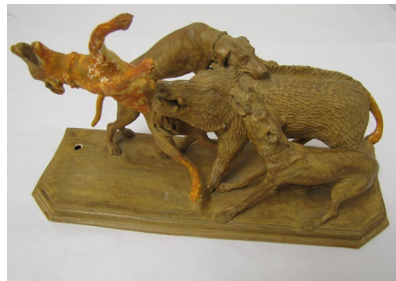
- ↑ An example of the effects of light on retouch of added parts of a ceramic sculptural group (colour layer degradation)
- ← An example of a porcelain vase with fine three-dimensional decorations (Meissen china) damaged by an uninformed person who handled it roughly.

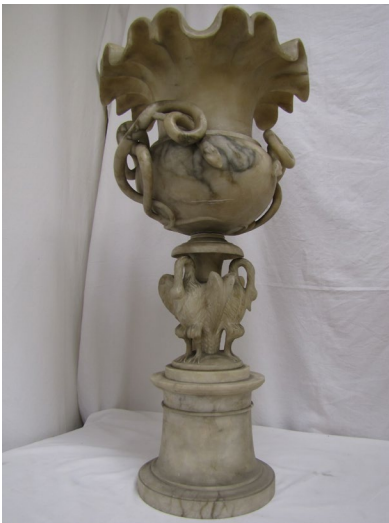
An example of the faded surface of a decorative alabaster vase due to long-term effects of air pollutants, especially dust

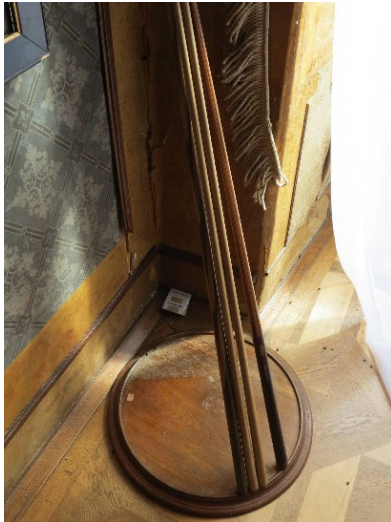
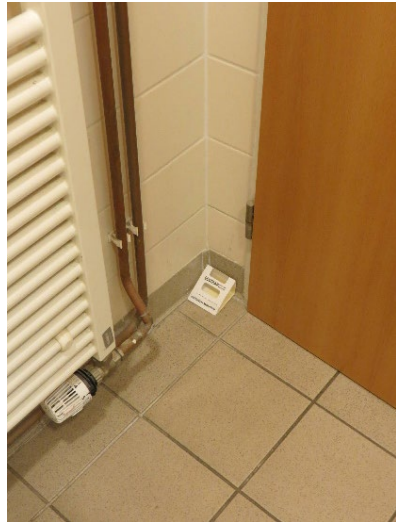
Fig. 1 and 2: Demonstration of the placement of the climbing insects' catcher.
On the right: Kunštát National Monument.
On the left: Sanitary room of the Moravian Gallery (hereinafter MG) depository.

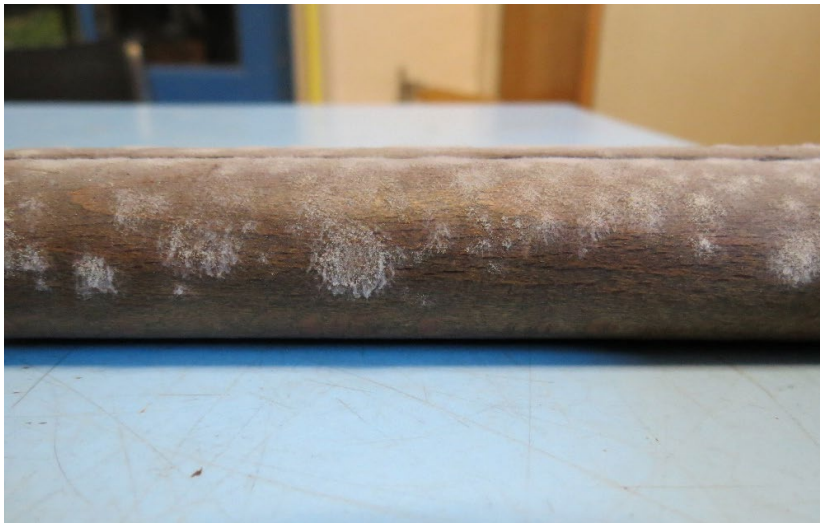
Fig. 3: The tram handle was damaged by a fibrous fungus (mould), the object was exposed to a local flow of air with high RH. From the TMB collections.

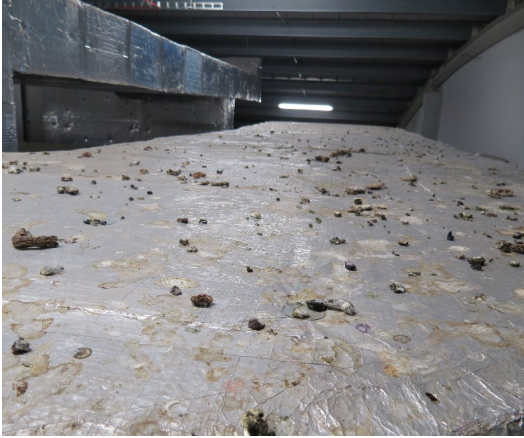
Fig. 5: Bird droppings after penetration of birds into the technical areas of MG depositories, providing sources for the development of microbiological or insect biologic activity or for direct aggressive effect on buildings or materials of cultural heritage.

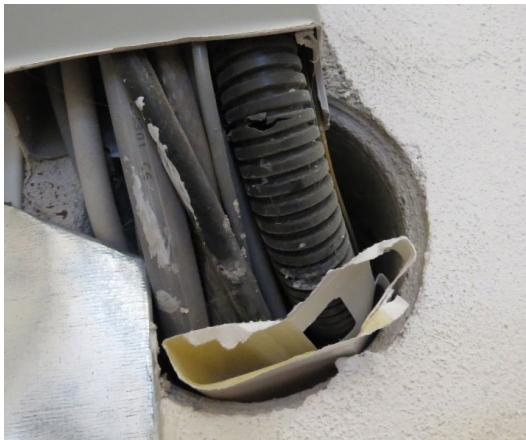
Fig. 6: Demonstration of the possibility of insect migration through insufficiently blinded electrical wiring with a laid-on insect trap.

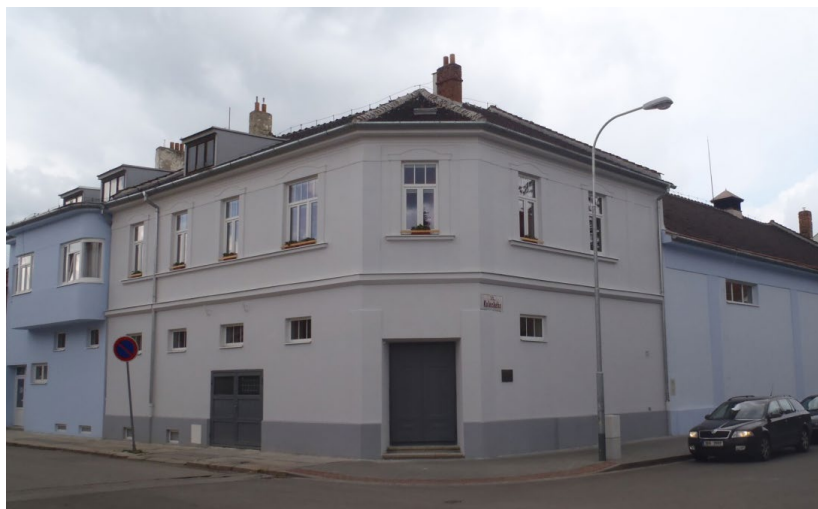
- ↑ View of the Bio Slavia cinema building, 1920s. Source: Archive of the Technical Museum in Brno
- ↑ The TMB depository and conservation workshops, view from the intersection of Rokycanova and Kaleckého streets after restoring facades and replacing windows in 2010. Source: archive of the Technical Museum in Brno.

The existing building is probably located on the site of the original Grand Bio Astoria cinema in Jungmannova Street (in 1933 the street was renamed to Rokycanova), which opened in 1912. In 1941 the name was changed from Bio Slavia to Sport. Under this name, the cinema ceased operation in 1966 due to safety faults in the electrical wiring and problems with its running, especially heating and ventilation. In 1970, state authorities decided to transfer this building to the TMB, and in the same year, a detailed design was carried out by the Morenda company to redevelop the depository. Construction work was completed in 1972. Conservation workshops were built as part of the redevelopment. They are partially located directly in the depository building, but most of them are in the vacant space created after closure of the boiler room, where other premises necessary for their operation were built and added.

At the beginning of the 1980s, a faulty roof truss with suspended ceiling above the original cinema hall was found. A temporary solution was found at the beginning of 1983 by reinforcing the truss and suspending the ceiling in the form of a lattice structure. The ceiling was then inspected regularly. In 2010, the façade was rebuilt, and a structural assessment report was prepared detailing the seriousness of the depository ceiling's condition. In 2014, the broken ceiling was stabilized and buttressed with a system of wooden supports.

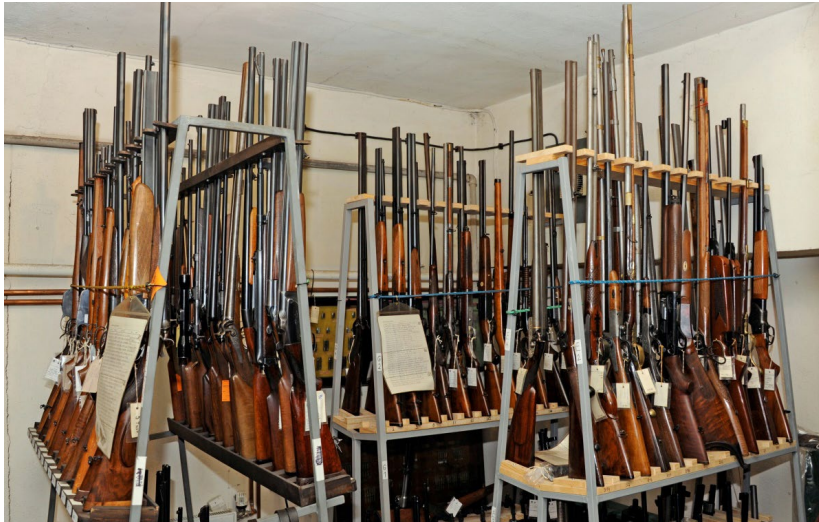
Special depository for storing militaria. Source: Archive of the Technical Museum in Brno.

The space was subjected to a microbiological survey due to the occurrence of fibrous fungi. Fibrous fungi or mould occur mainly on the surface of wooden parts of weapons and textiles or leather belts. Interestingly, mould was also discovered on metal parts of the weapons. The Depository is permanently dehumidified due to the decrease in humidity, which naturally ranged above 65 % RV. This problem has been monitored for a long time and a microbiological survey was carried out in 2001. Samples were taken from the weapons and separate cultivations were carried out by exposing the cultivation soils directly in the depository. In 2015, the survey was repeated and the growths were evaluated at the Textile Testing Institute. Once more, growths were taken from wooden, leather, and metal parts of the weapons. Both surveys proved the presence of

these moulds: *Penicilium sp.*, *Aspergillus sp.*, and *Chaetomium sp.*⁵. These types of fibrous fungi are often found in interiors, soil, or on objects. Their activity is dependent on the conditions in which spores occur. Its occurrence on the metallic parts of the weapons is probably caused by the application of a preservative that has formed a suitable substrate for mould development. The environment in the armoury area has been monitored since March 2013.

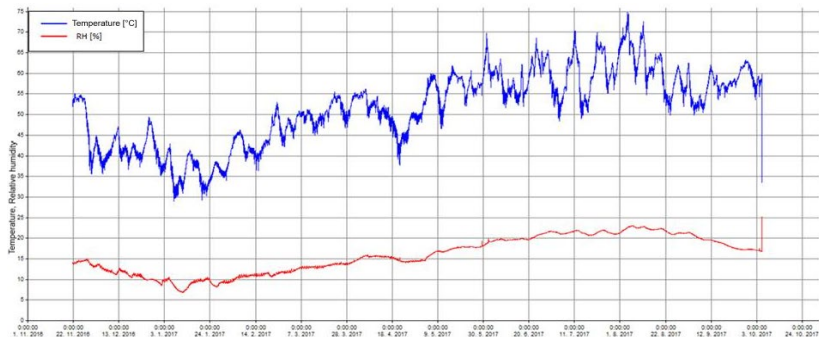
RH/T records from Special Depository No. 3, sensor No. 07931674, while the experiment was monitored (after removing the dehumidifier)

It is clear from the graphs that the measures taken did not compensate for fluctuations in temperature and relative humidity values. After removing the dehumidifier, RH values slightly increased within acceptable limits, as can be seen from Fig. 3. In summer, RH achieves acceptable boundary values. A positive outcome of the experiment can be seen in the improvement of overall air exchange and mainly in its directed flow. Increased air circulation prevented the development of mould in the deposited militaria.

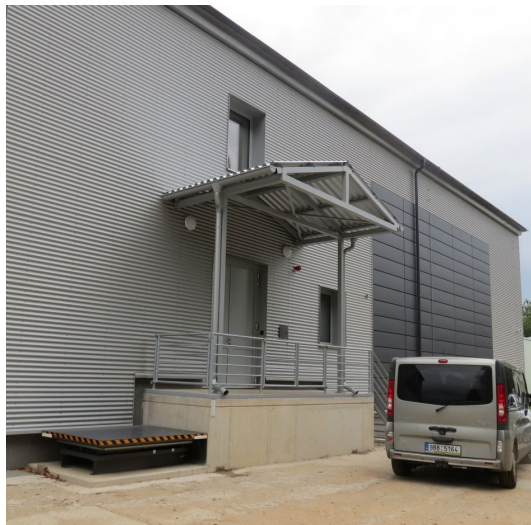
The new depository in Brno – Řečkovice. Source: Archive of the Technical Museum in Brno.

At the time of this text's publication, the depository is already empty and these objects have been relocated to a new depository (Fig. 4) that meets all the requirements for optimal storage, both in terms of indoor environment quality and protection and security.

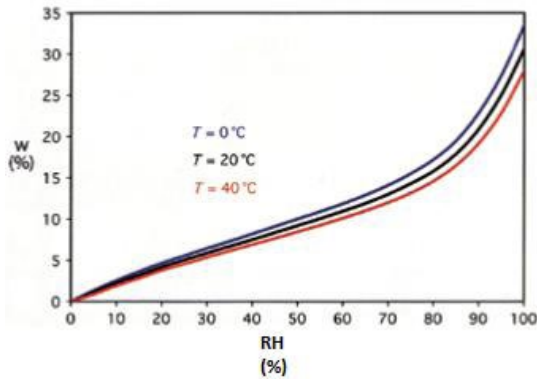
Fig. 1: Sorption isotherms of wood at different temperatures (w – equilibrium moisture content in wood, RH – relative humidity), adjusted according to Camuffo, 2014, pp. 84. It is clear from the sorption isotherms that the moisture equilibrium of the material also depends on the ambient humid air temperature.²

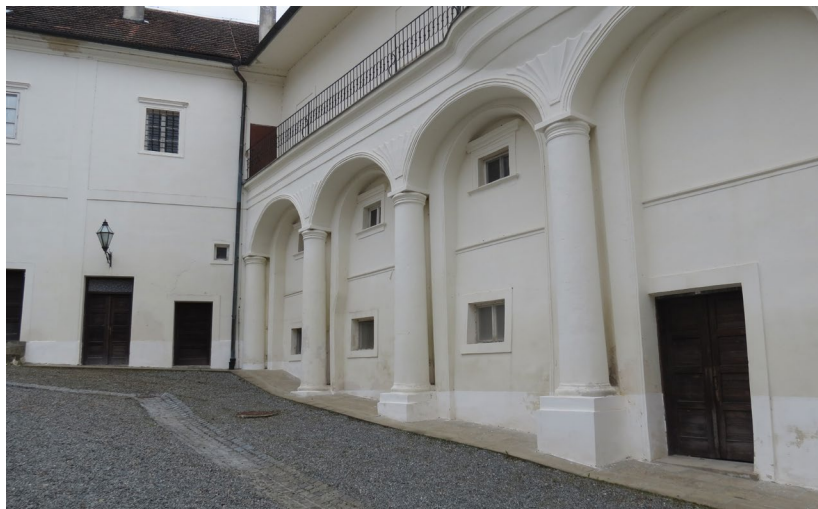
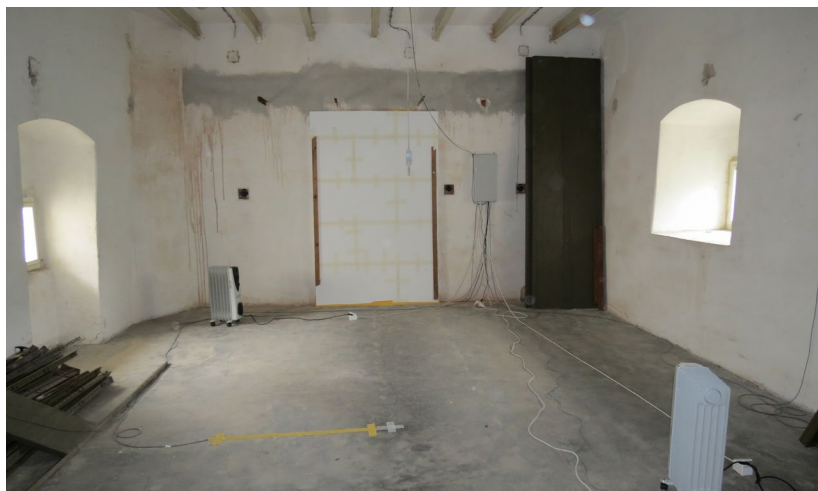
- ↑ *Fig. 2: Kunštát Lower Chateau, National Heritage Institute. On the right is the north wing of the building where the conservation heating experiment took place on the second floor. Photo©Technical Museum in Brno.*
- ↑ *Fig. 3: Experimental room 118 at the Kunštát Lower Chateau. Door openings were sealed with polystyrene board. Photo©Technical Museum in Brno.*

Experimental verification aimed at determining the effectiveness of the conservation heating system in local climatic conditions. The Lower Chateau Kunštát premises at Kunštát State Castle were chosen for the experiment (Fig. 2). It is a listed historical building and was adapted to the storage of archival materials in the 1960s. Currently, the structure is not used and its next renovation is planned as a repository. Two rooms (No. 117 – *Reference*, and No. 118 – *Experimental*) were selected, located on the second floor of the north wing of the building (Fig. 3). These areas have not been tempered in recent years and have exhibited a higher long-term RH of about 70%. Both rooms were equipped with the same number and type of RH / T sensors for the experiment. The temperature and relative humidity parameters of the outdoor environment were measured by a sensor located at the window of room 117 on the northern wall of the building. All windows in rooms 117 and 118 were closed. The rooms connected via door openings (no doors installed), which were sealed with polystyrene boards 50 mm thick so that room 118 could not be influenced by the microclimate in reference room No. 117 or the environment in the other adjacent parts of the chateau itself. An MS6D data logger was used as the central unit for controlling, collecting, and recording data into memory, together with a relay card for switching the heating on. Heating was provided by two oil radiators with output power adjustable to 600, 900, or 1500 W. Total energy consumption was also measured by a special device located outside the monitored room.

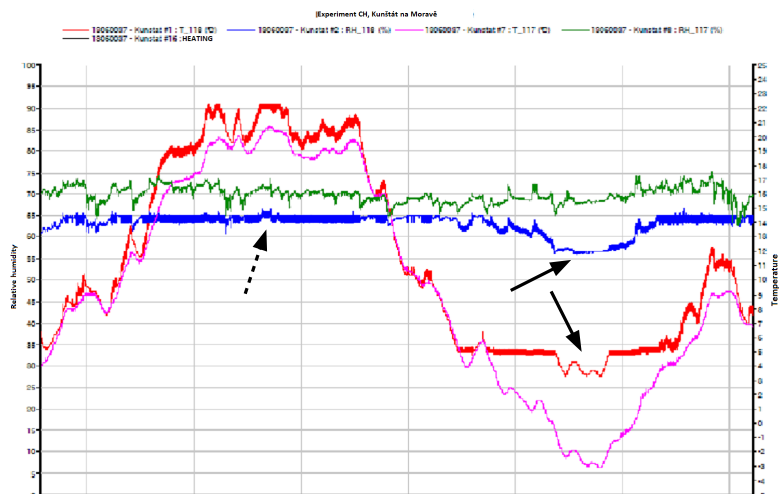
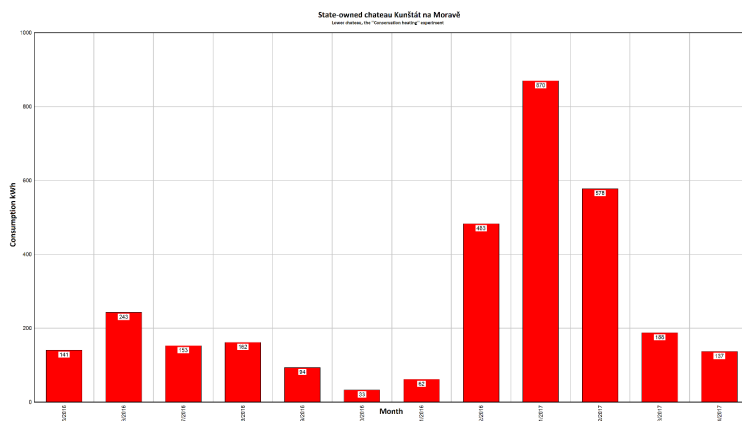
- ↑ Fig. 4: Measurement from March 2016 to April 2017 of RH and T parameters in the reference and experimental rooms, including the heating units switching on and off.
- ↑ Fig. 5: Monthly electricity consumption (May 2016 to April 2017).

The opposite situation occurs in the summer months when the upper limit T_118 of 22°C is achieved and the heating elements switch off and a slight increase of RH_118 above 65% (marked with a broken arrow in the graph) occurs. Total electricity consumption for the period 01.05.2016 to 28. 04. 2017 was approximately 3.15 MWh. The monthly consumption is shown in Fig. 5 and external climatic conditions are shown in Fig. 6.

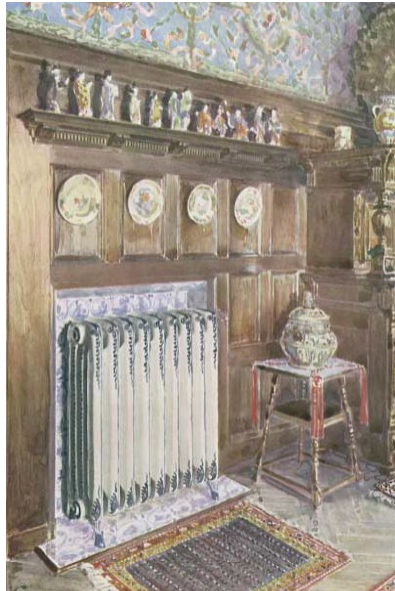
Radiator, period publication.
Photo: Author's archive.

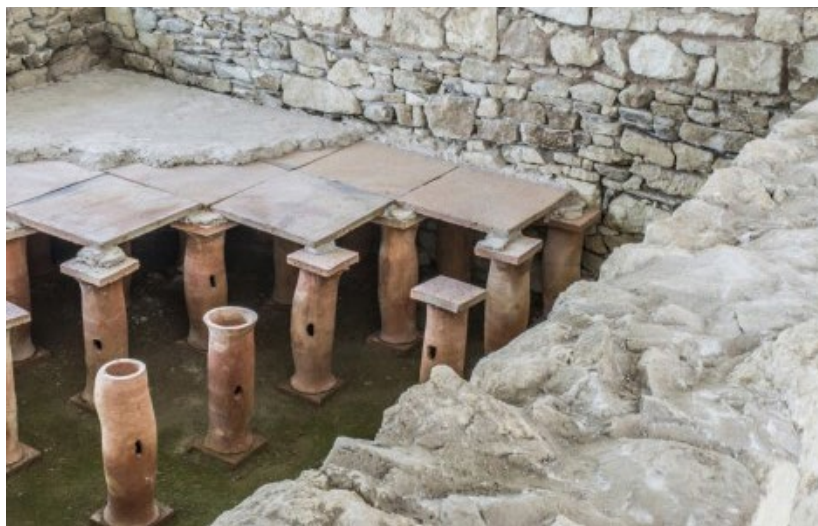
Hypocaustum – a view of the floor construction heated with flue gas. Photo: Cejnová, Miroslava. Fireplaces preserved in castle kitchens. In: *Proceedings 1/2003, Proceedings from 1st Conference on Construction and Historical Survey 4–6th June 2002 at the Zahrádky u České Lípy chateau*. Prague: Unicornis, 2003. ISBN: 80-86562-00-X.

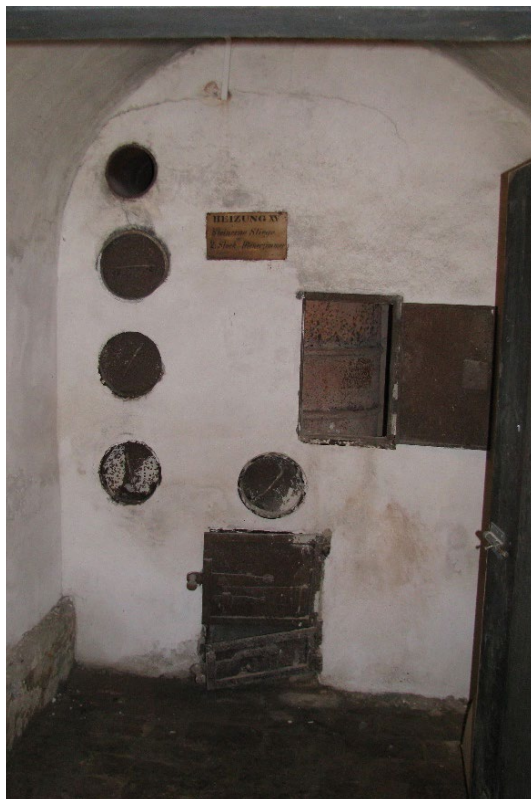
Iron stove in a heating chamber. Photo: V. Holásek.

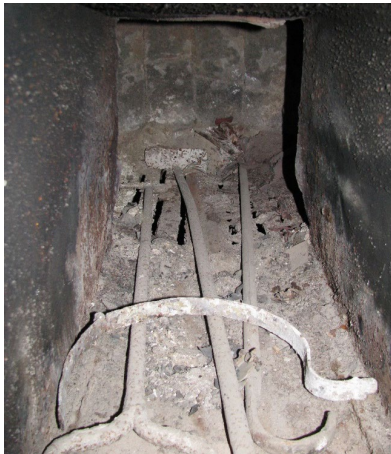
Substrate in the hearth of a damaged iron stove. Photo: V. Holásek.

Deactivated heaters, including local units, often contain a significant amount of ash and soot from the time it was last used. This is true even at locations where only surface appearance is maintained. The retained substrate, a nutrient broth for biological agents, maintains increased moisture, which particularly damages the metal parts of heaters.

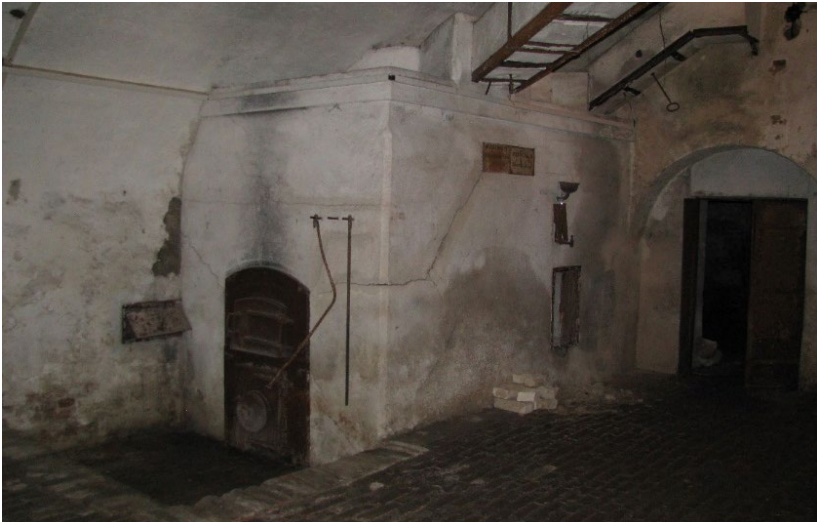
- ↑ Design of boiler room with low pressure steam heating. Lednice Chateau. Author: Samuel Bollinger, around 1840. Photo: Authors.
- ↑ Area for operating a hot air heating system with a calorifier. The heating chamber is fitted with a revision door and water level indicator to control the water level in the evaporation vessel for humidifying the air. A control panel for the hearth is at the front part of the heater. Two channels for hot air distribution lead from the calorifier. Lednice Chateau. Photo: Authors.

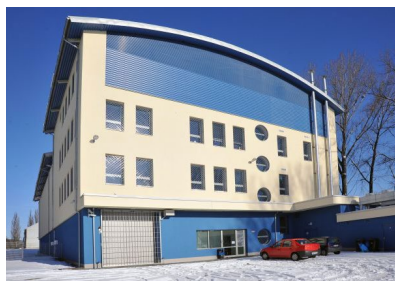
CENTRAL DEPOSITORY OF THE MORAVIAN GALLERY IN BRNO

The main depository of the Moravian Gallery in Brno was built from 2006–2008, the useful area in the depository rooms is total 2,157.7 m² and houses collections of fine and applied arts (the major part of applied arts collection is deposited in another building). The total number of objects stored is approximately 78,000 pcs (i.e. 40% of the entire collection, however, 70% of the volume of the entire collection because large objects are often deposited here) which are classified according to individual collections and stored in individual rooms. Besides depositories there are also restoration workshops, a disinfecting room, archive, research rooms, office rooms and other operating rooms.

The air-conditioning system in the main depository is based on air-conditioning units for individual rooms located on the top floor (under the roof above the 3rd aboveground floor, the air-handling plant is situated above the technical section of the building). The source of heat for the building is a gas boiler room with two boilers (each with an output of 234 kW) in an adjacent ground-floor extension. The air-conditioning system coolers are located on the roof of the extension. Two compressors with an input of 59.1 kW each are used for cooling and are installed in the air-handling plant. The existing air-conditioning system is on the upper limit of its output and it is not possible to connect any other rooms to it.

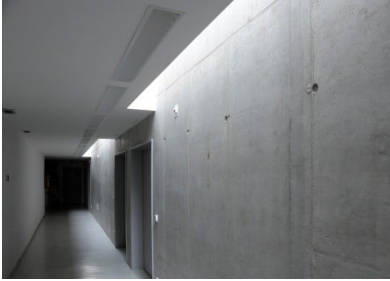
DEPOSITORIES IN THE APPLIED ARTS MUSEUM

The Applied Arts Museum houses especially objects from the collections of applied arts and design. There is a depository for pottery and porcelain, glass, metals, textile, art collections from the Orient, graphic design, and a depository of photographs and new media. The number of objects stored is approximately 120,000 pcs (i.e. 60% of the entire collection, however, only 30% of the volume of the entire collection because especially small objects are deposited here).

The air-conditioning system is central allowing individual setting according to the requirements for keeping individual materials.
